CPDLC

Maastricht Upper Area Control Centre

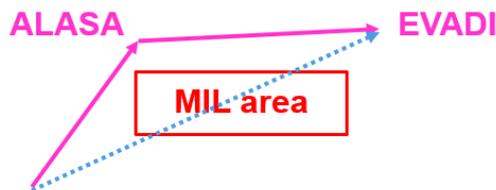
Example: **CLEARED TO EVADI[FIX2] VIA ALASA[FIX1]**

Note: Some airframes display the message as **CLEARED TO [FIX] VIA ROUTE CLEARANCE**, which leads to regular misinterpretations. ALWAYS look for the additional points.
